# Truckee Canal Failure on 5 January 2008

## Investigative Evaluation Report

March 2008

U.S. Department of the Interior  
Bureau of Reclamation  
Mid-Pacific Region  
Sacramento, California

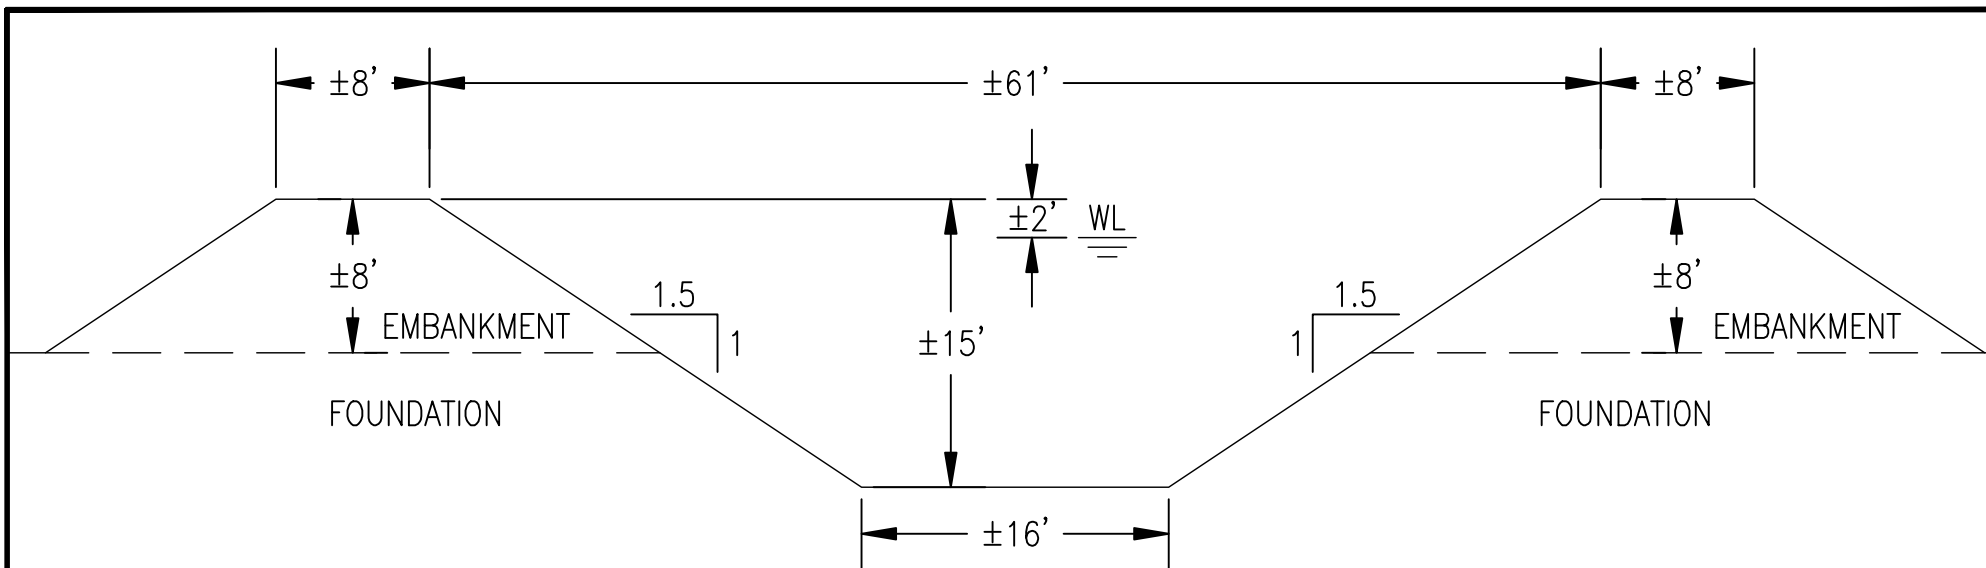
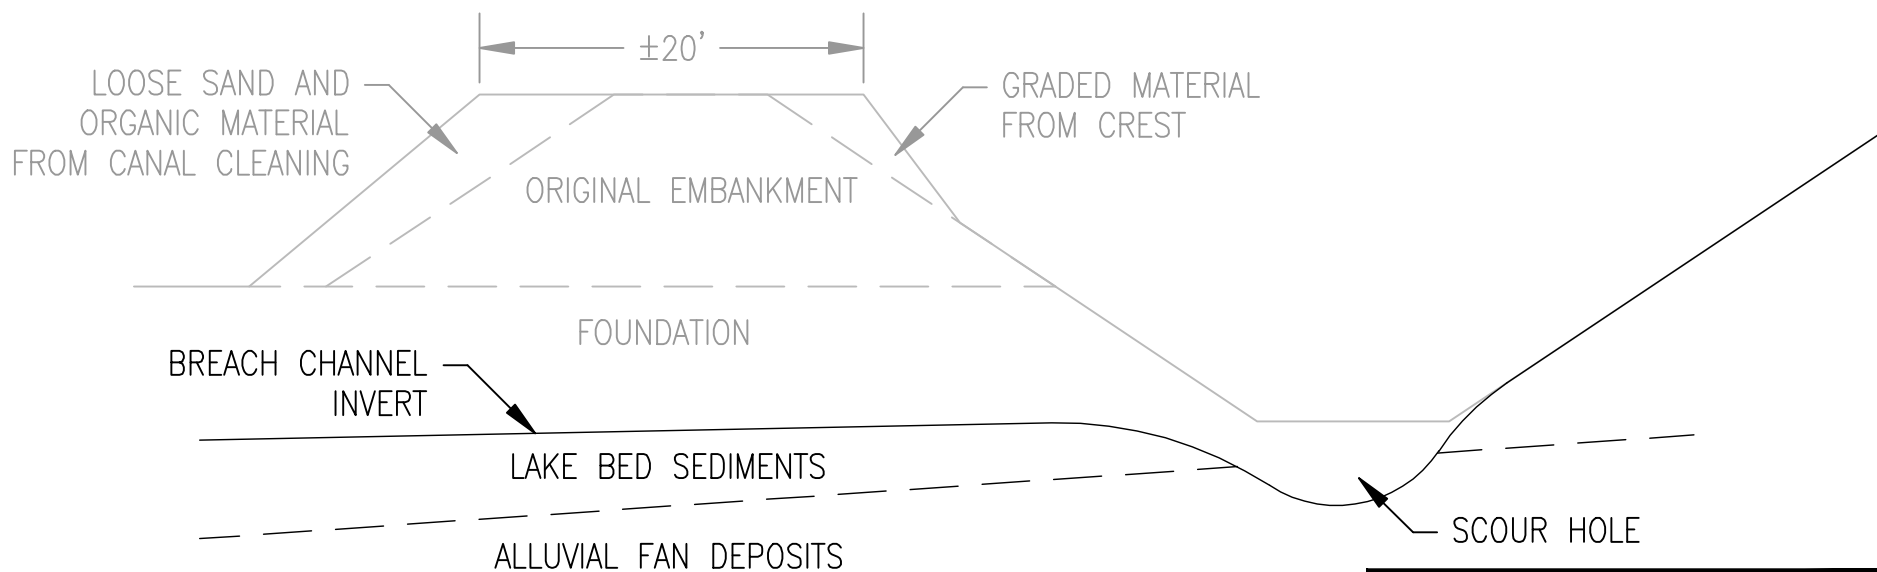
**FIGURE 1  
TRUCKEE CANAL BREACH**

The canal embankments, which are approximately 8 feet high adjacent to the canal cut in the breach area, are composed of a homogeneous mixture of silt and clay with minor amounts of sand and gravel. Embankment lift lines are not distinct and there are no horizontal layers of pervious material. The landside embankment slope is blanketed with sand and vegetative material derived from years of periodically cleaning out the canal. The bond between the embankment material and the lakebed sediment foundation is excellent. Figure 1 shows a cross section through the breach, with the existing embankment projected in the background.

ORIGINAL CANAL CROSS SECTION

CROSS SECTION THROUGH BREACH

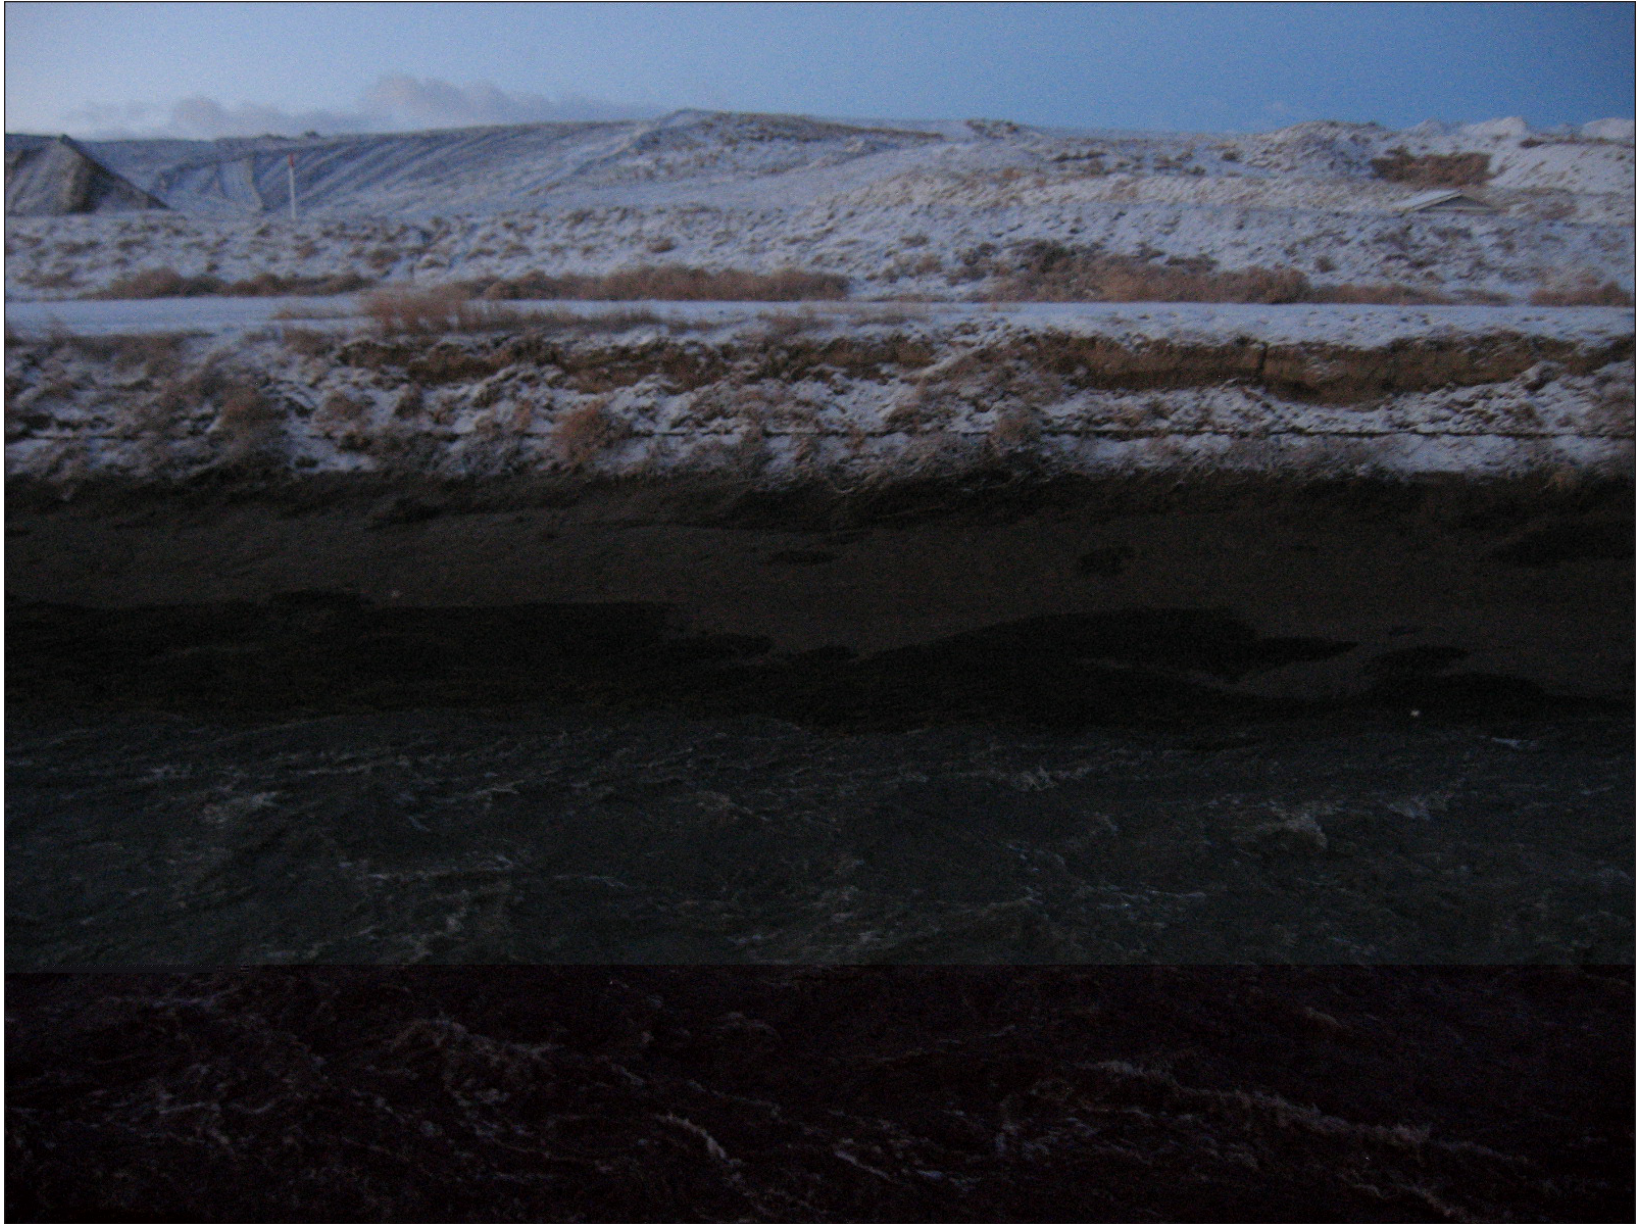
Overtopping was judged to be extremely unlikely as a factor in the failure, because all of the available information suggests that the water level at the breach location did not rise above elevation 4,193.0 mean sea level (msl), which is 3.5 feet below the canal embankment crest at about elevation 4,196.5. Although gage data suggest that canal flow was relatively high at the time of the failure, flows up to 20 percent higher have been recorded in the past without overtopping. No evidence of erosion of embankment crest was observed in the vicinity of the breach, and the location of the breach has never been reported as a low spot in the embankment crest. Photographic evidence and eyewitness reports indicate that snow was present on the waterside slope of the embankment some distance below the crest elevation immediately after the failure; any snow would have been melted to the crest level had the embankment overtopped.

Photo 1. First photograph taken at point of failure. View looking south across canal. Note high water mark in canal during high flow event as evidenced by fresh snow. Photo by Walt Winder, 6:08 a.m., 01-05-2008.

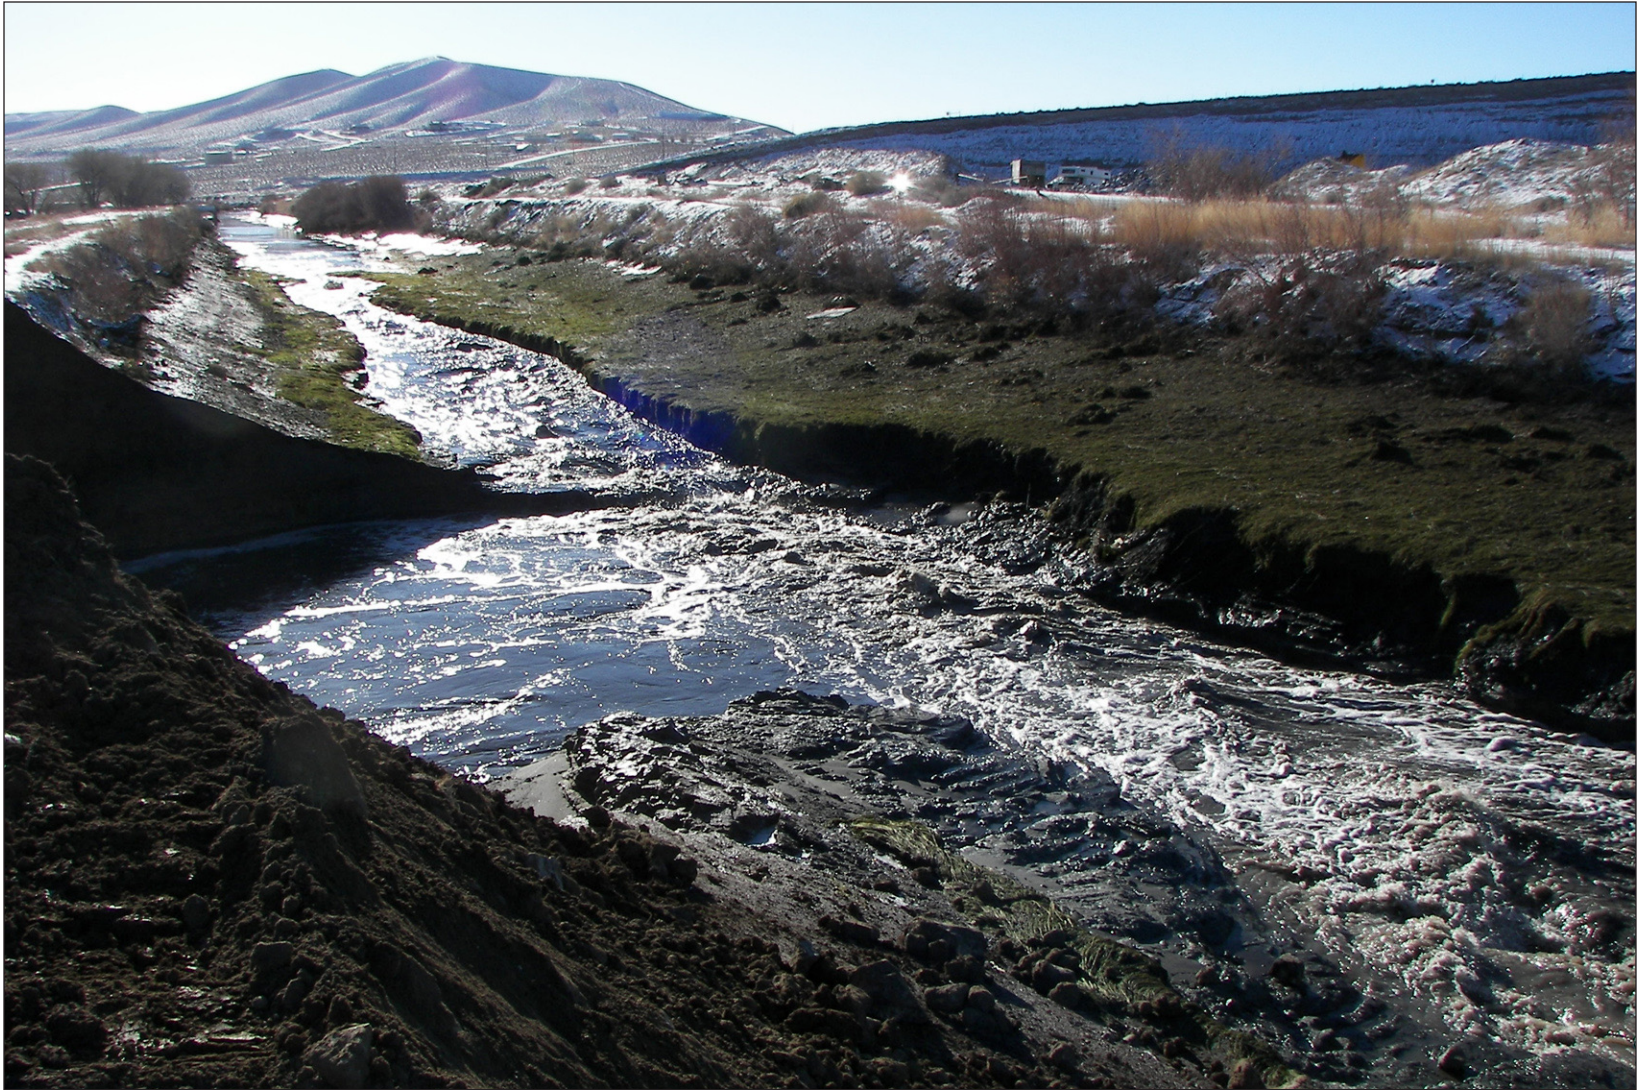
Photo 2. Canal looking downstream (east). Breach at left. Photo by Walt Winder approximately 6:15 a.m., 01-05-2008.

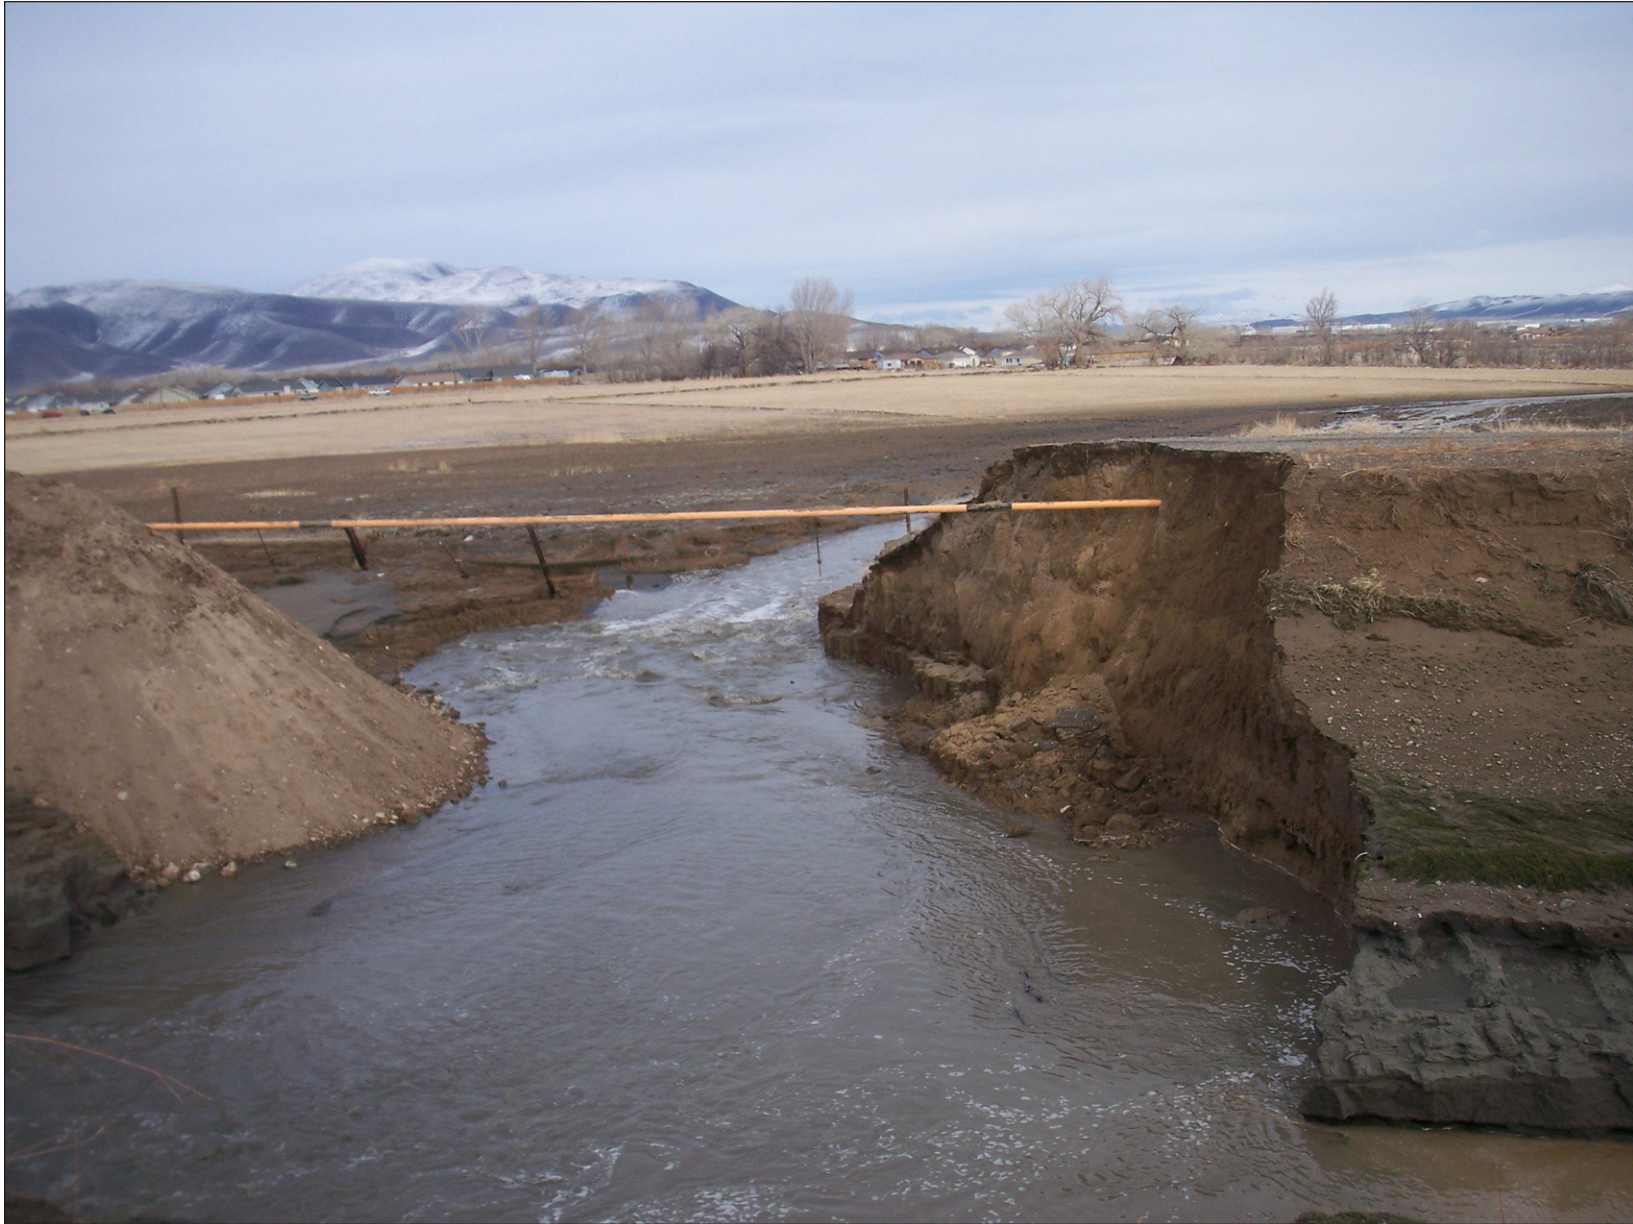
Photo 3. Canal breach (about Sta. 714+00) looking north. Water flowing towards Fernley. Water normally flows left to right. Photo by Kenneth Parr, 1:04 p.m., 01-05-2008.

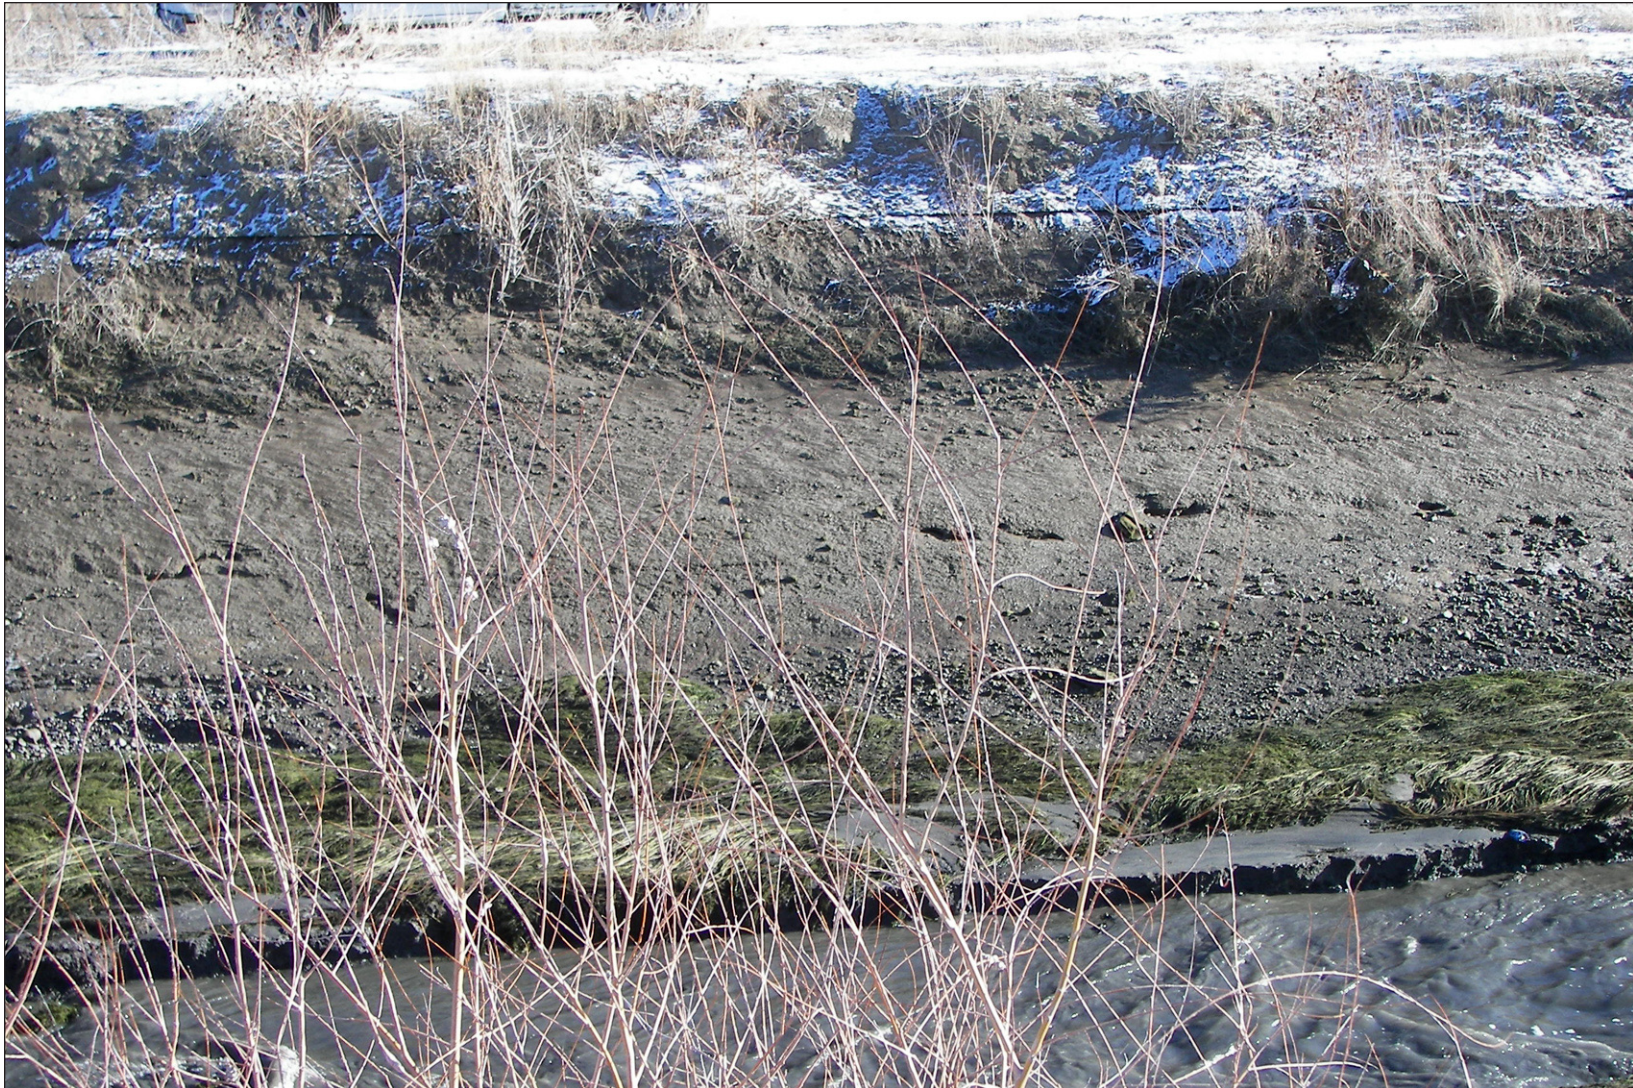
Photo 4. Drained canal clearly showing high water level during high flow event as evidenced by unmelted fresh snow which fell during early morning hours of 01-05-2008. Photo by Ernie Schank.

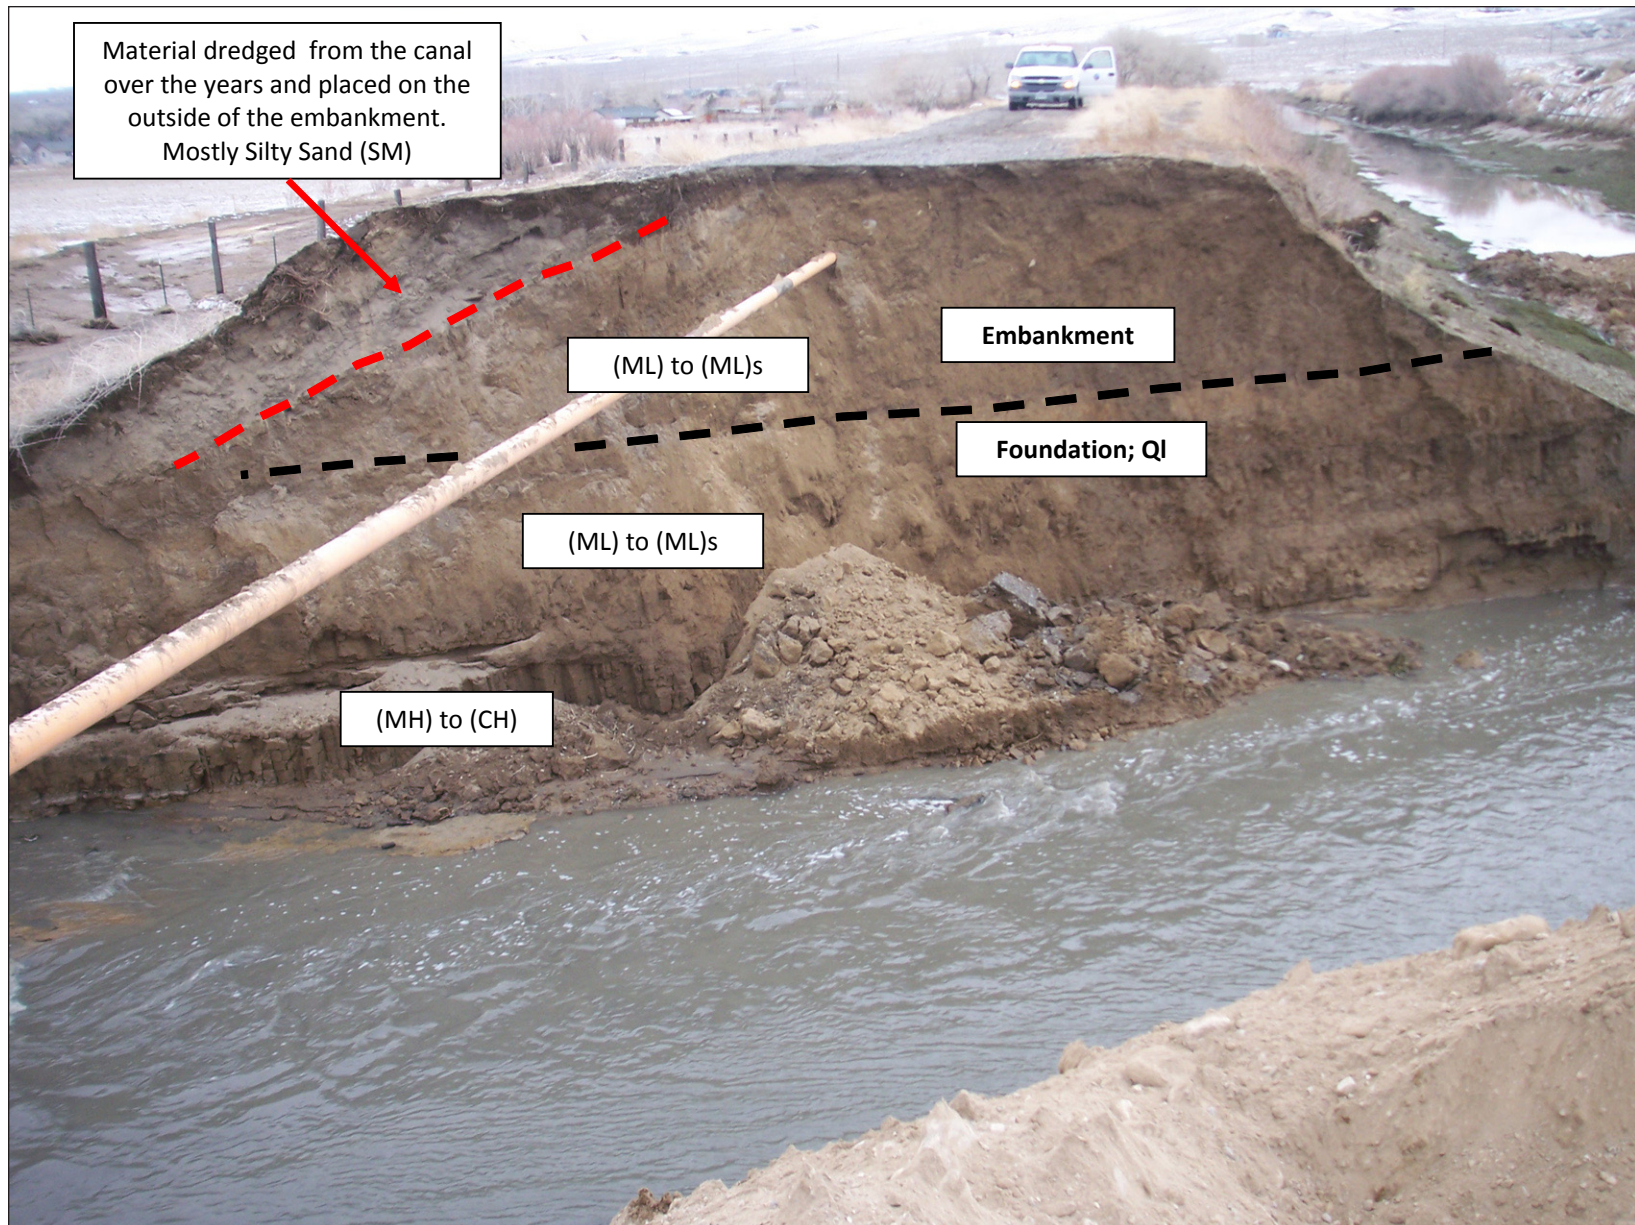
Photo 5. Downstream view of canal breach. Dashed black line is approximate contact between canal embankment and in-place lakebed deposits (QI). Center-left is an abandoned Sierra Pacific Power gas pipeline. Photo by Kenneth Parr, 2:07 p.m., 01-05-2008.

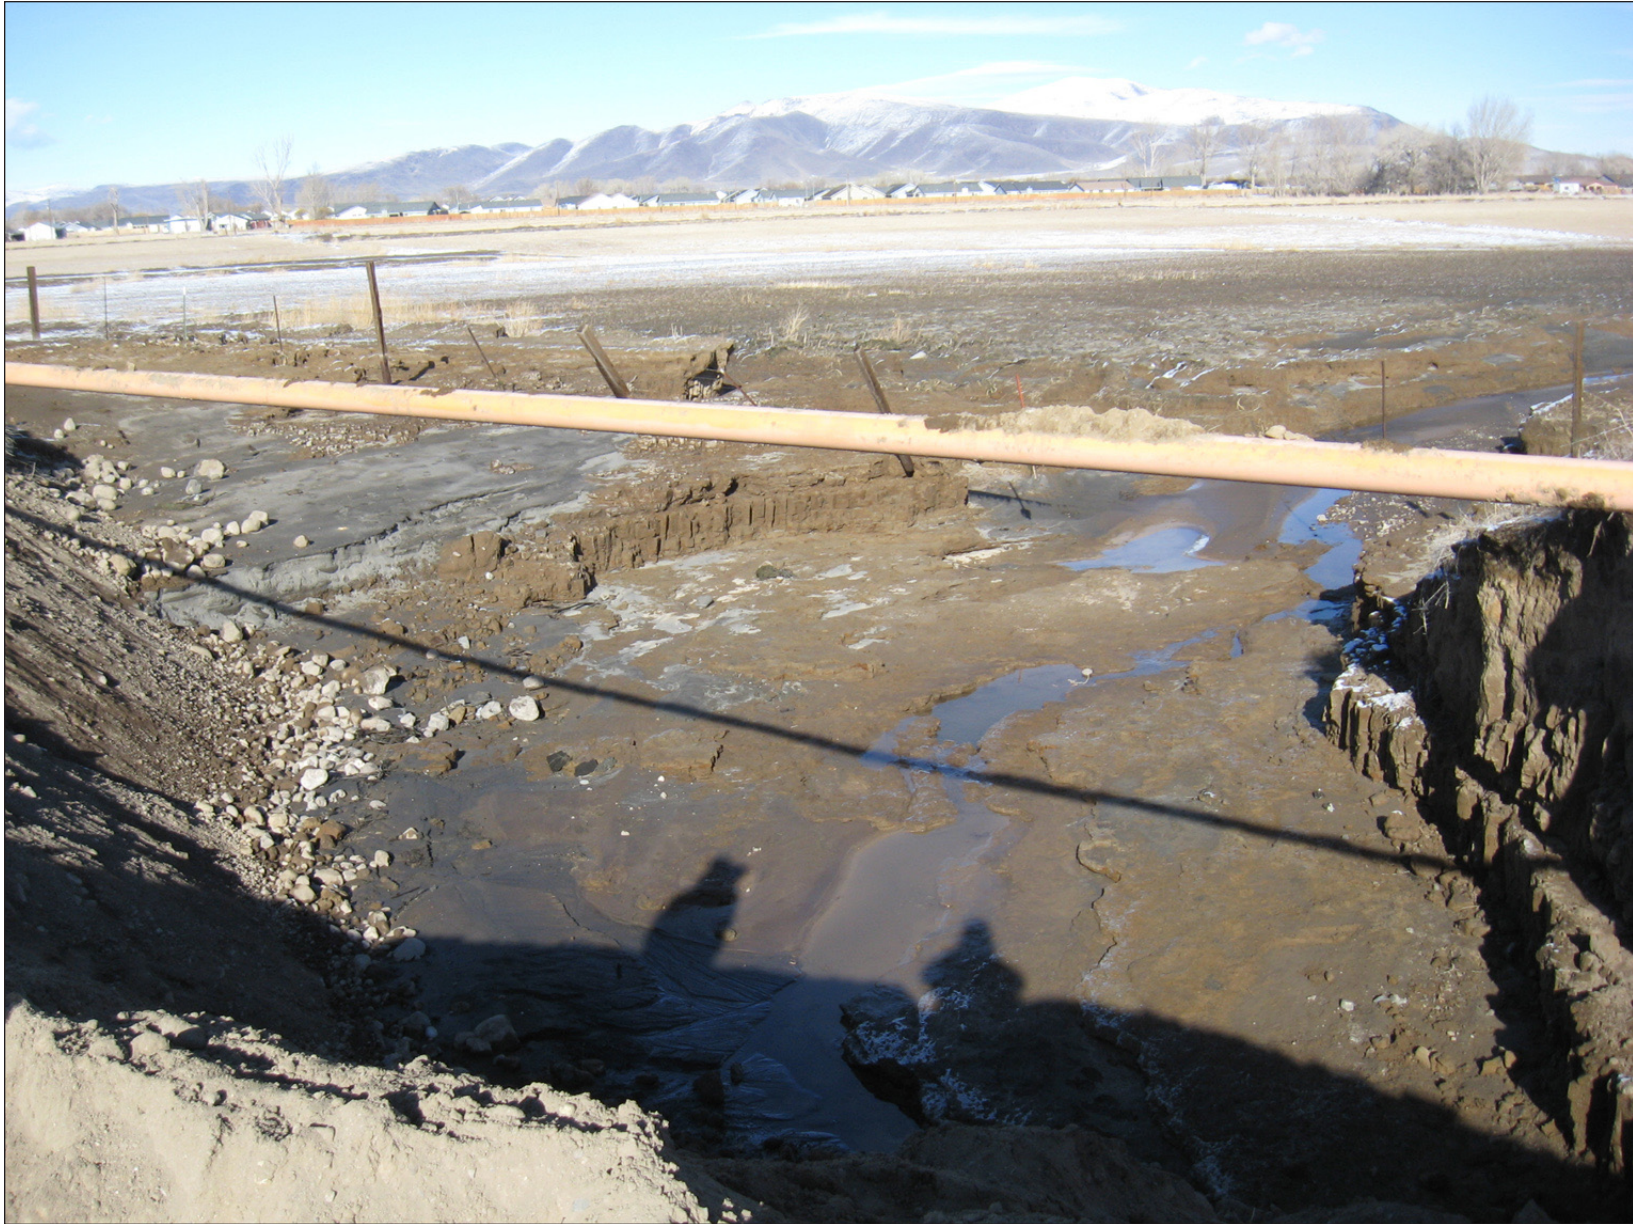
Photo 6. View towards Fernley from top of the breach plug. Photo by M. McCulla, 01-06-2008.

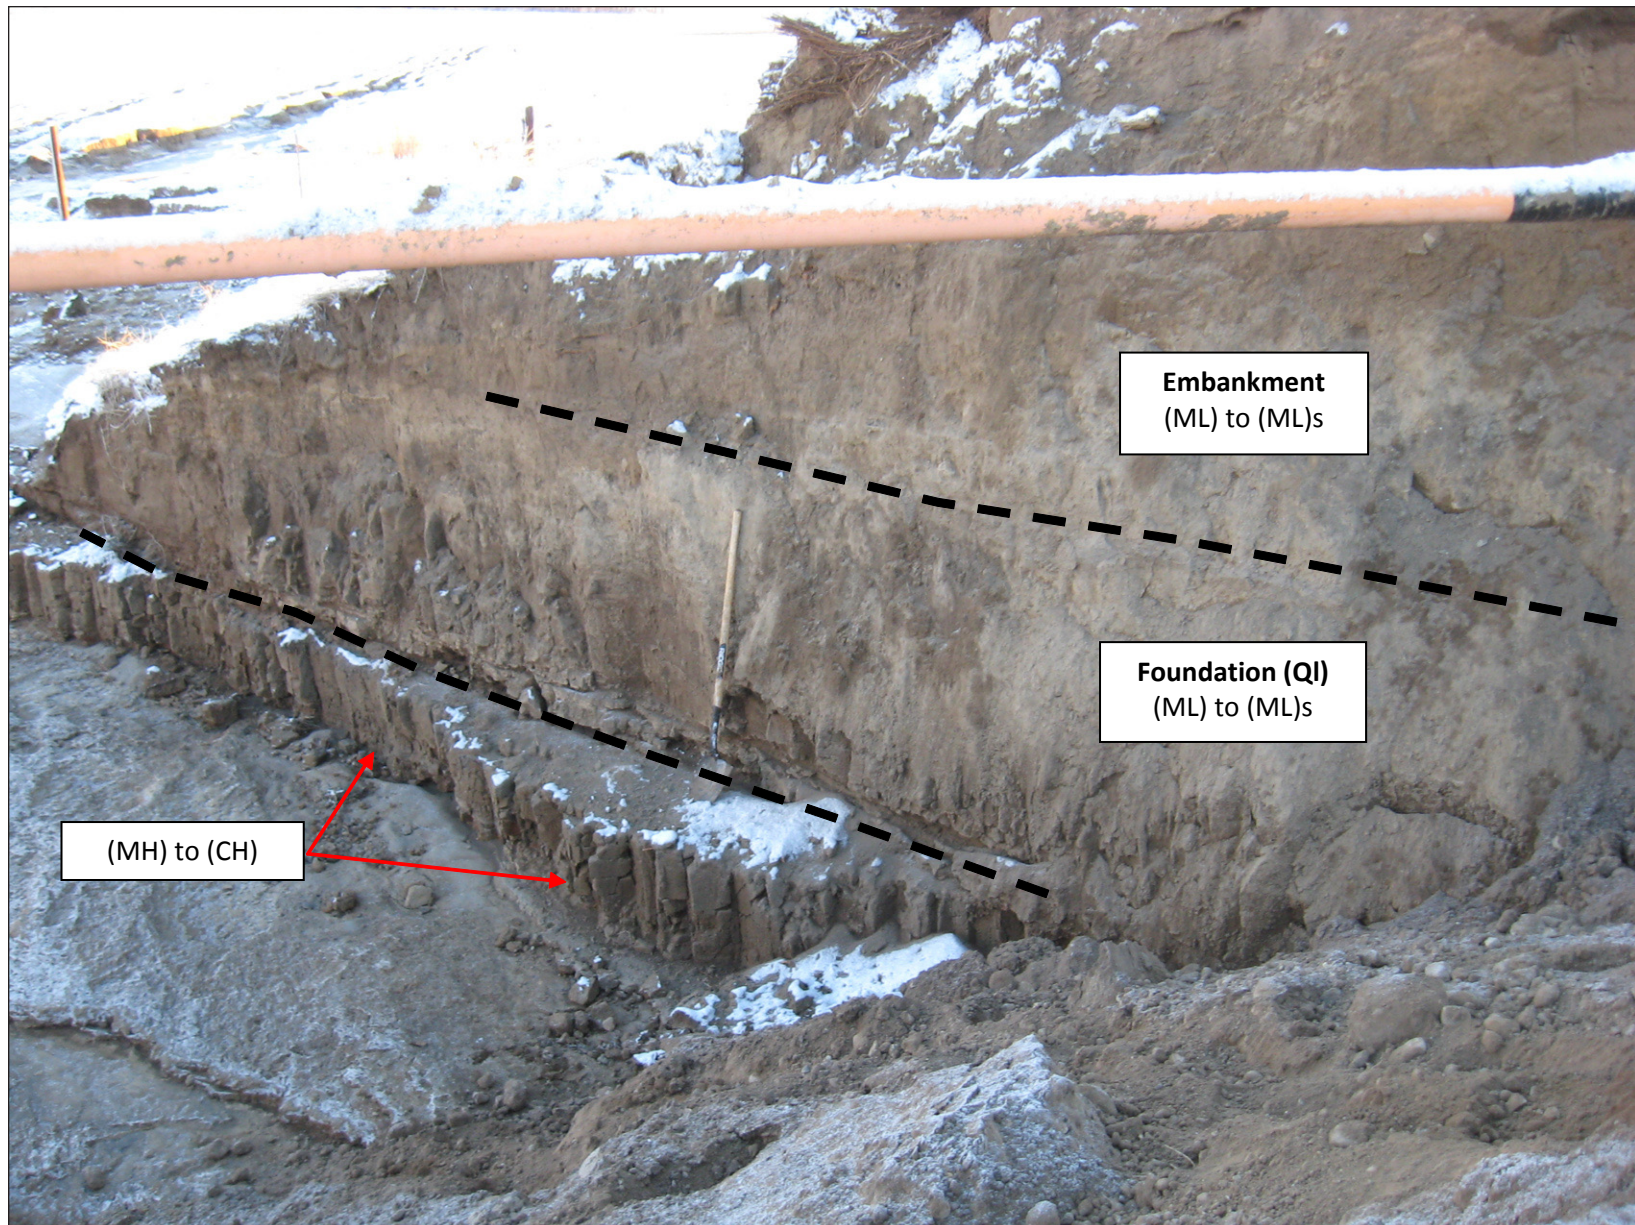
Photo 7. View of downstream face of breach showing approximate contact between embankment and in-place Quaternary lakebed sediment (QI). Photo by M. McCulla, 01-06-2008.

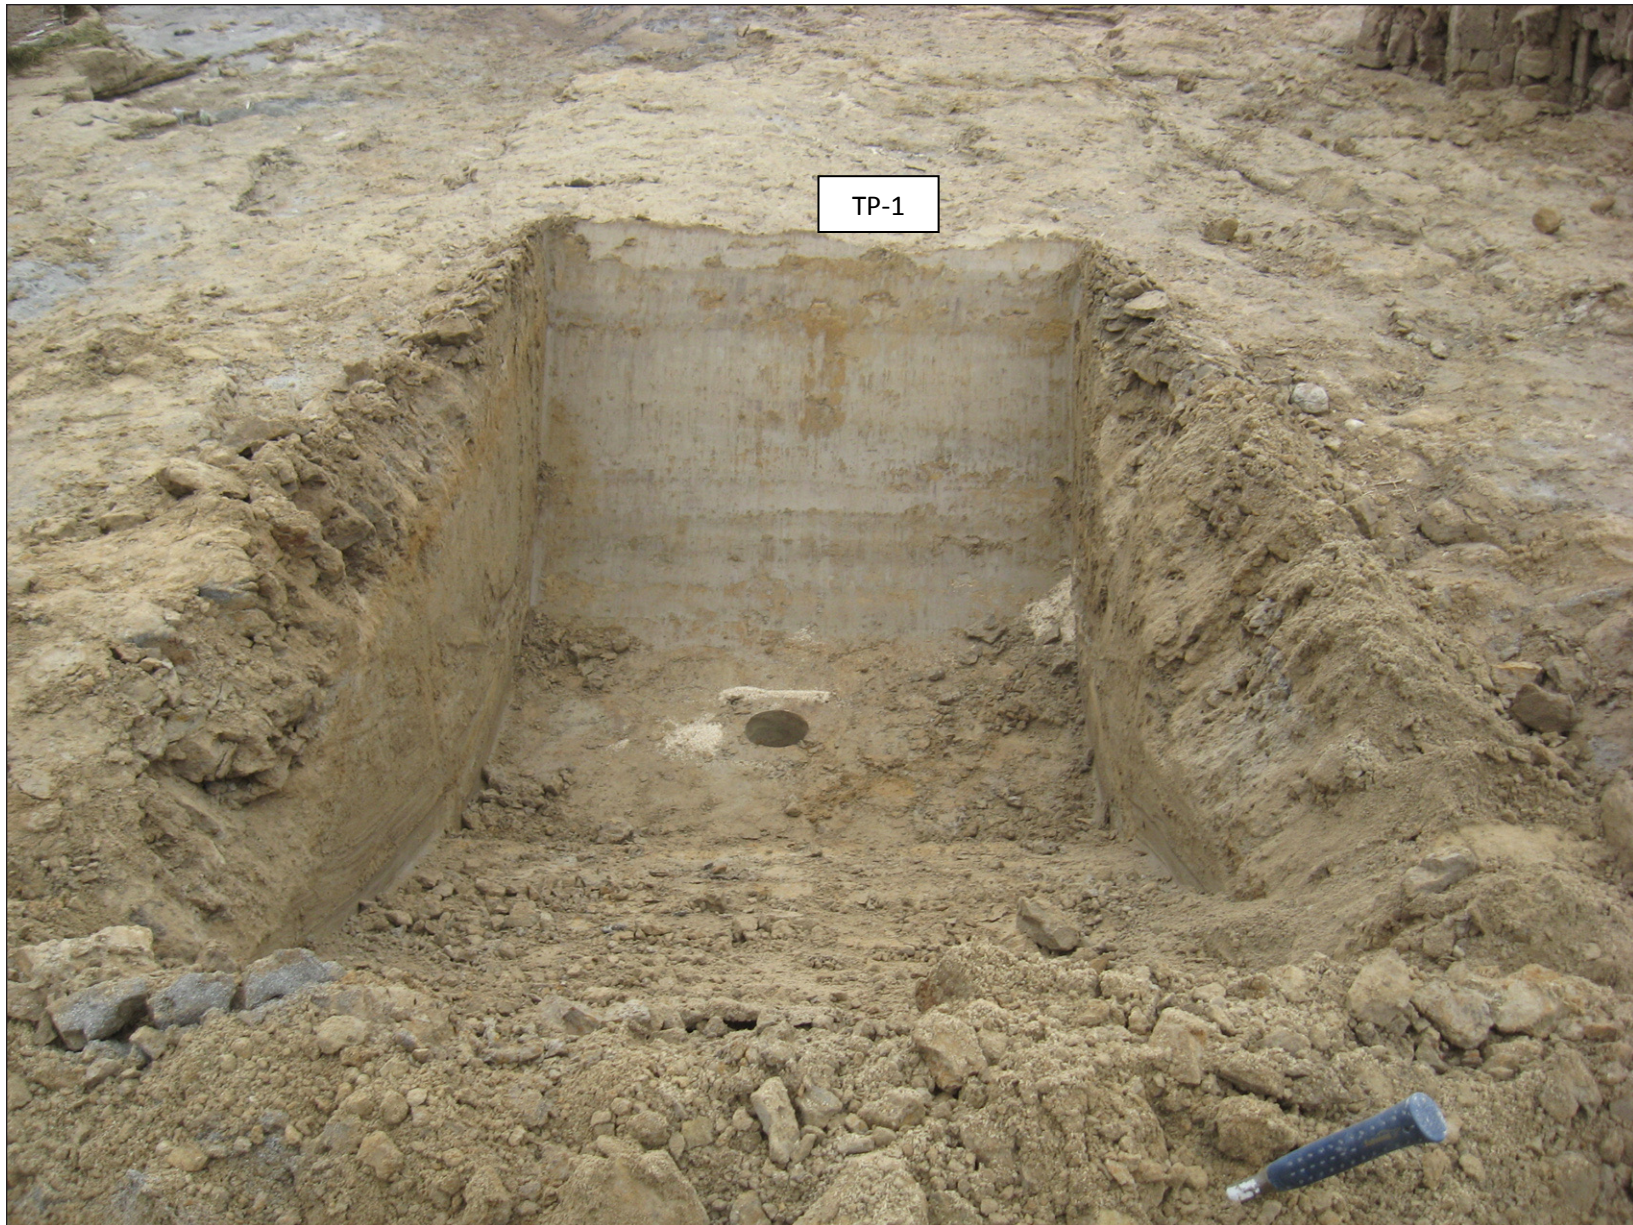
Photo 8. Test located in the invert of breach. Test pit was in lakebed sediments. Photo by M. McCulla, 01-13-2008.

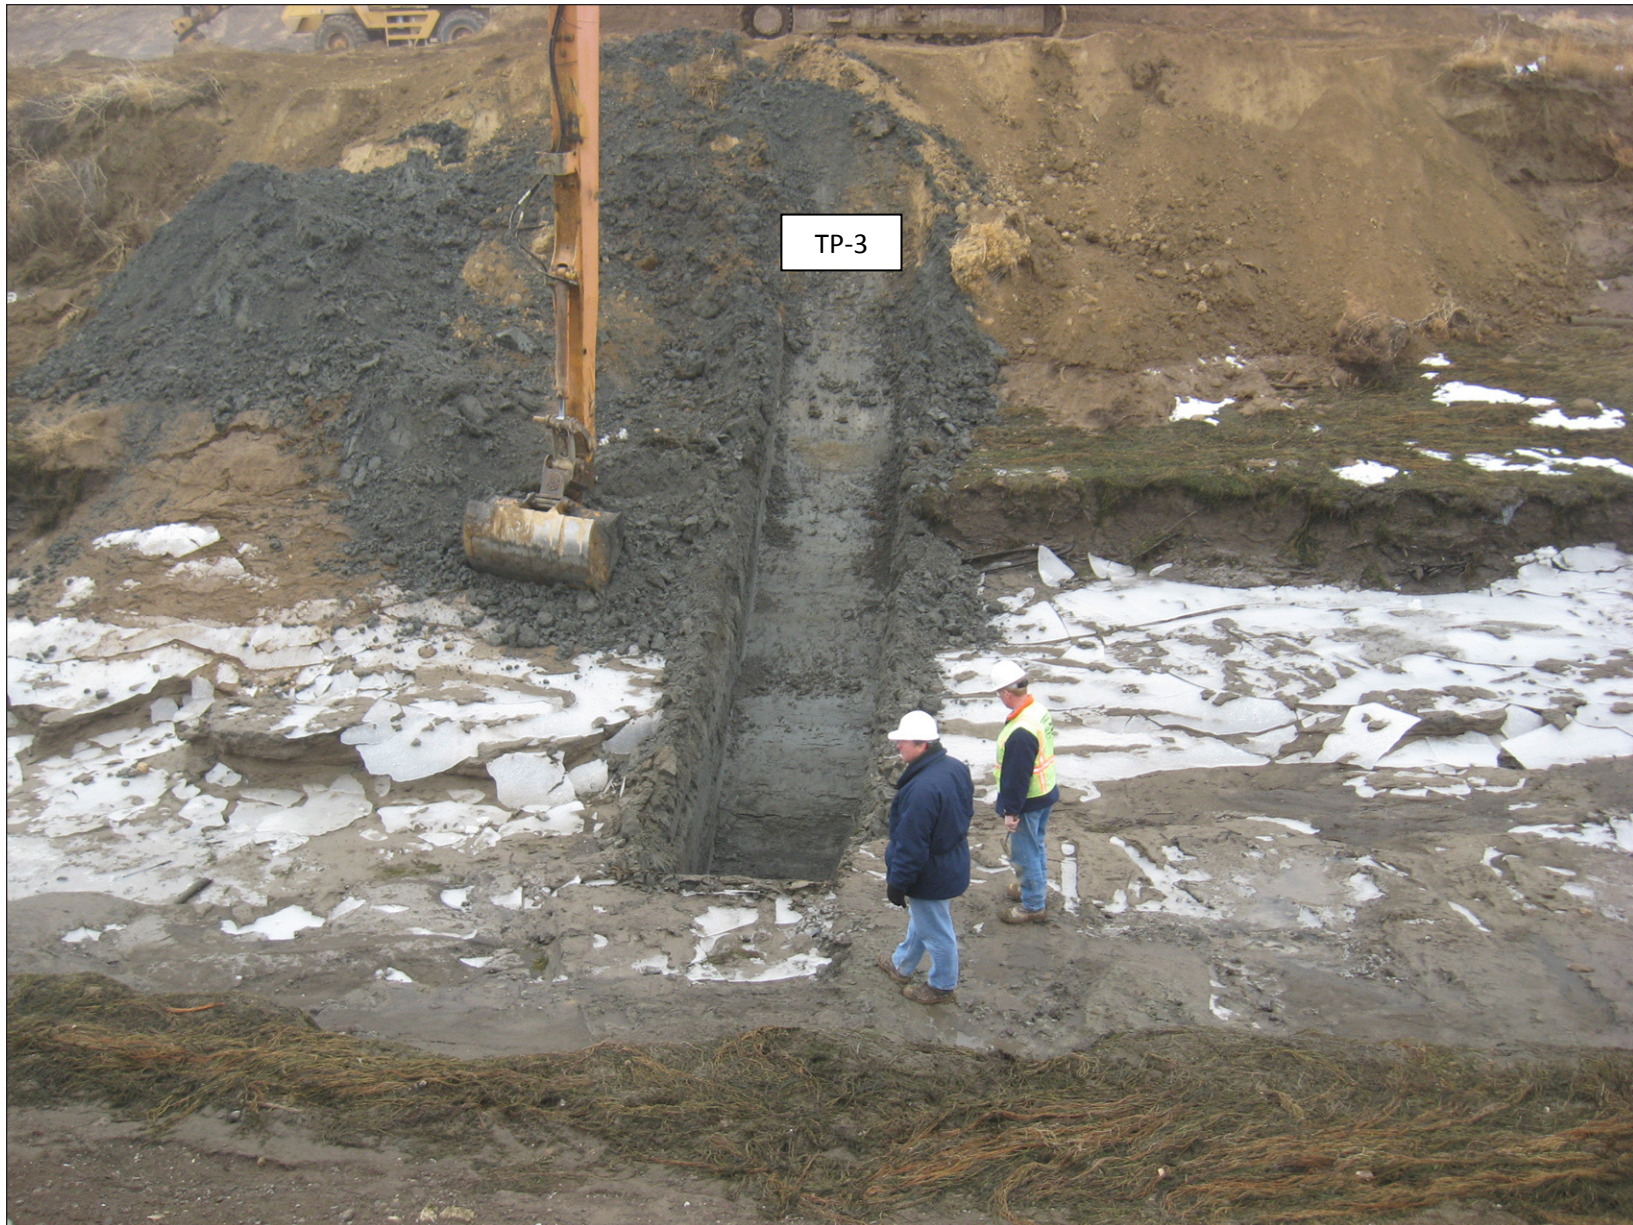
Photo 9. Test pit about 120 feet upstream from breach. Test pit exposed lakebed sediments overlying alluvial fan deposits. Photo by M. McCulla, 01-13-2008.

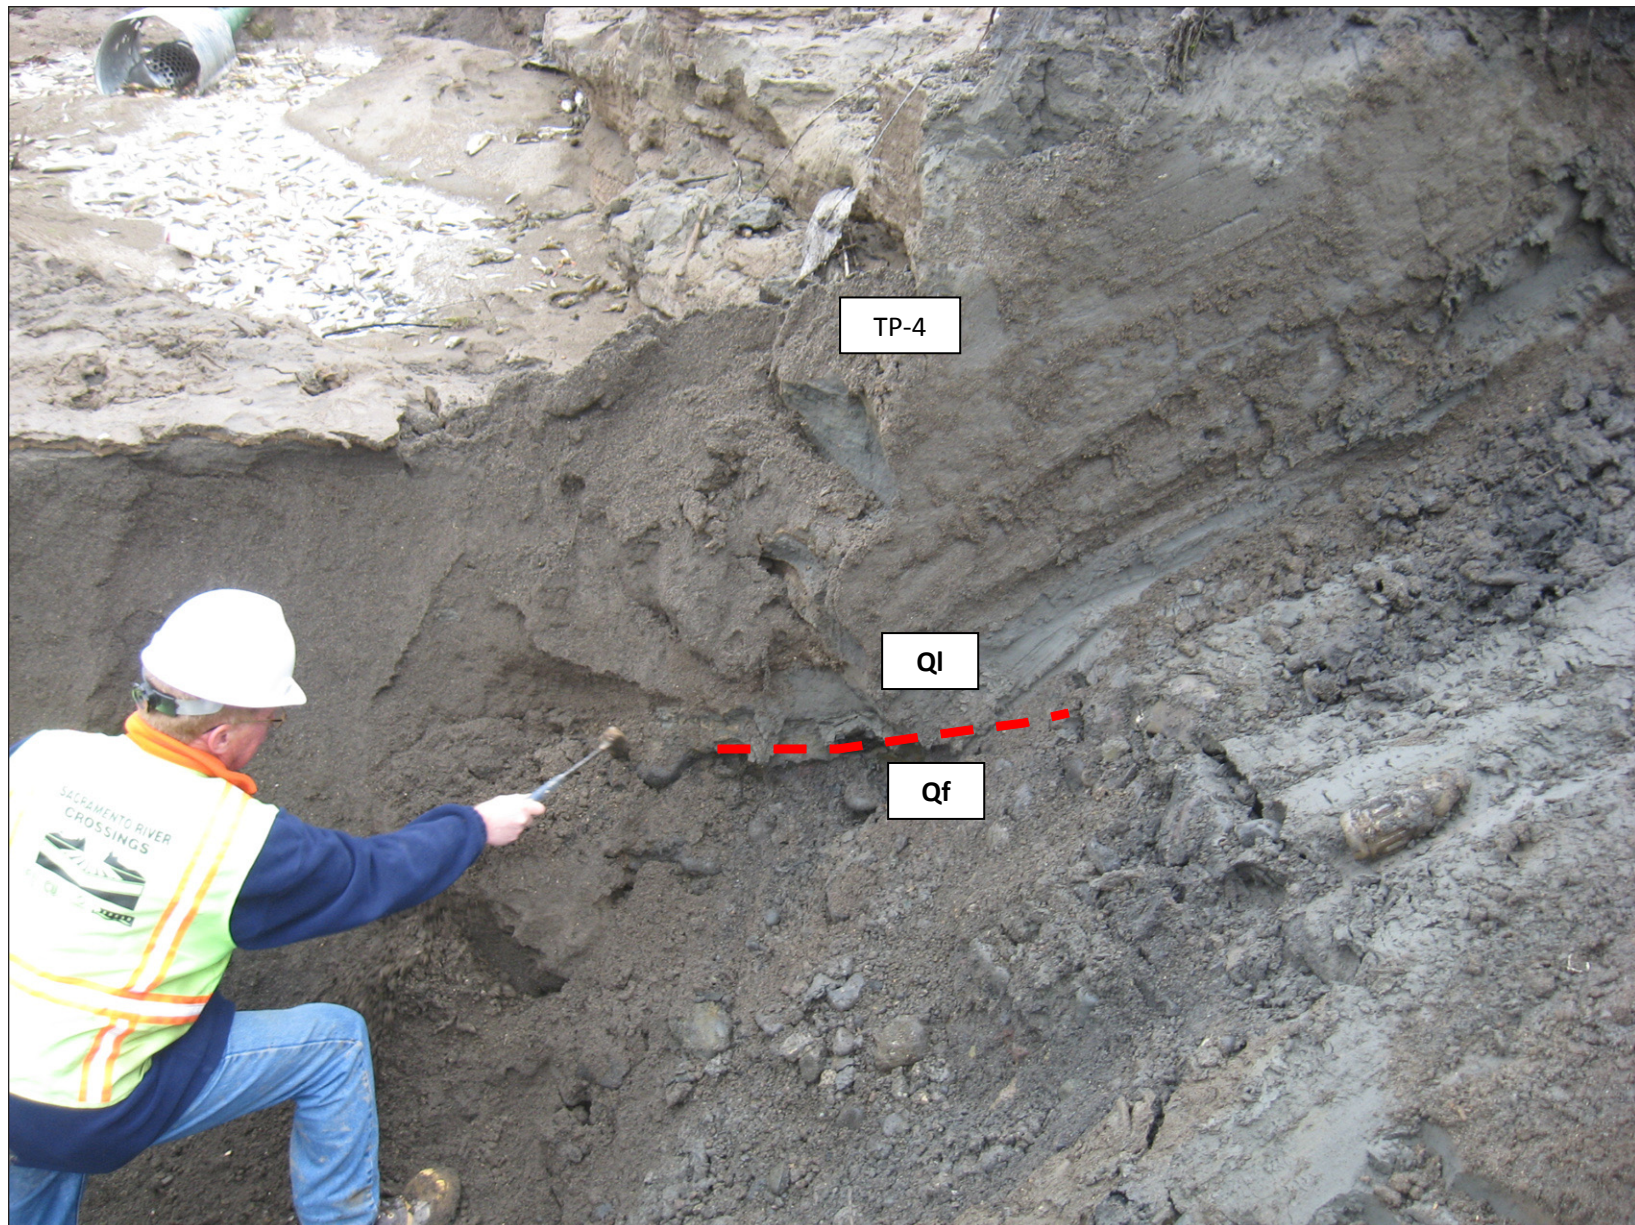
Photo 10. Test pit showing contact between alluvial fan deposits and overlying lakebed sediments. Photo by M. McCulla, 01-13-2008.
